## EXPERT ANALYSIS OF PROPOSED BORDER WALL AND BUOY SYSTEM ON THE RIO GRANDE RIVER IN WEBB AND ZAPATA COUNTIES, TEXAS, USA

PREPARED FOR: Rio Grande International Study Center  
PREPARED BY: Mark R. Tompkins, PE, Ph.D, FlowWest  
DATE: 03/10/2026

### PURPOSE

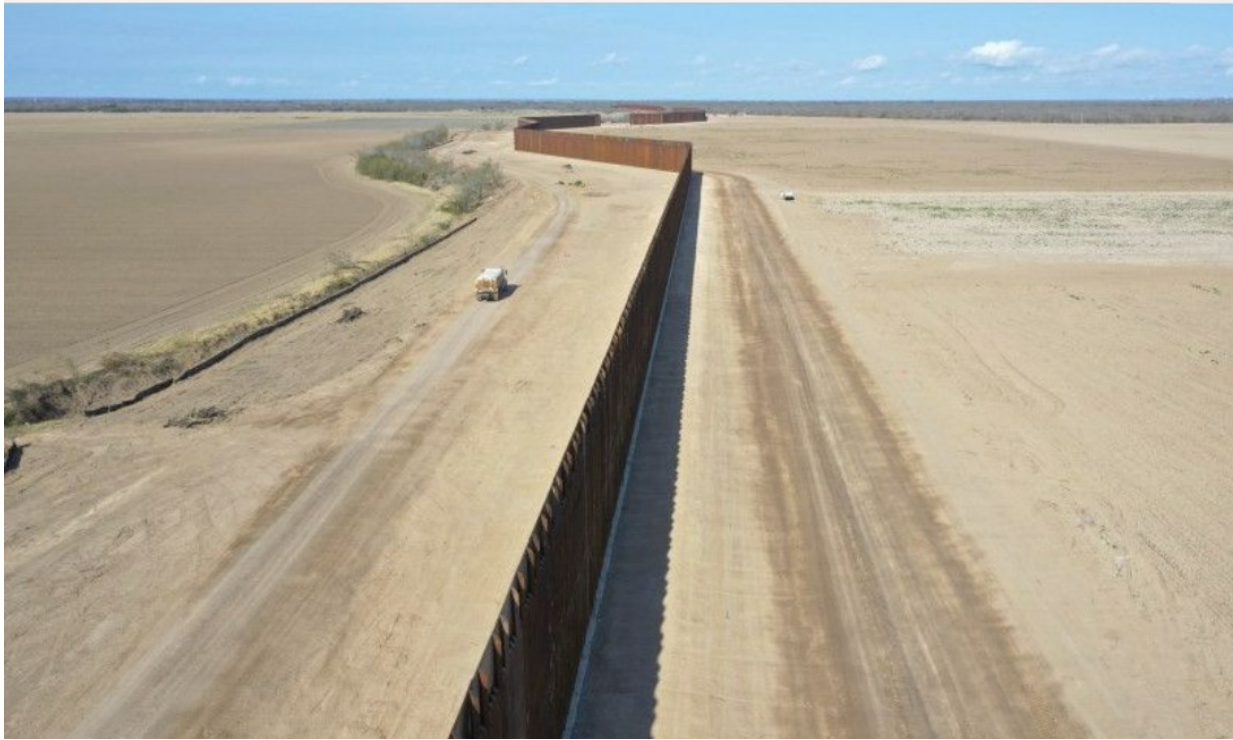
FIGURE 1: REPRESENTATIVE IMAGE DEPICTING THE SCALE OF THE WALL, MAINTENANCE ROAD, AND PATROL AREA COMPONENTS OF THE PROPOSED SYSTEM. SOURCE: [HTTPS://WWW.CBP.GOV/DOCUMENT/ENVIRONMENTAL-ASSESSMENTS/BORDER-BARRIER-AND-WATERBORNE-BARRIER-SYSTEM-WEBB-AND-ZAPATA](https://www.cbp.gov/document/environmental-assessments/border-barrier-and-waterborne-barrier-system-webb-and-zapata)

The CBP plans to construct a "border and waterborne barrier system" (system) in and adjacent to the Rio Grande River throughout Webb and Zapata counties, Texas ([CBP 2025a](#)). The system is massive and will drastically alter the hydraulic and geomorphic conditions of the Rio Grande River. The system includes approximately 108 miles of "primary border barrier" (wall) and approximately 153 miles of "waterborne barrier system" (buoys). The system also extends for many miles upstream and downstream of the portions in Webb and Zapata Counties. Presumably due to the waiver issued by the Department of Homeland Security (DHS) regarding this project, basic design documents and supporting analyses typically required for river corridor projects much smaller than this one are not publicly available. Therefore, the exact scale of proposed infrastructure can only be assumed from representative images provided by CBP. Figure 1 and Figure 2 are representative images of the proposed wall, maintenance road, patrol area, buoy, and anchor elements of the proposed system (from [CBP 2025b](#)) that include features (e.g. vehicles, roads, river) indicating the scale of the proposed system.

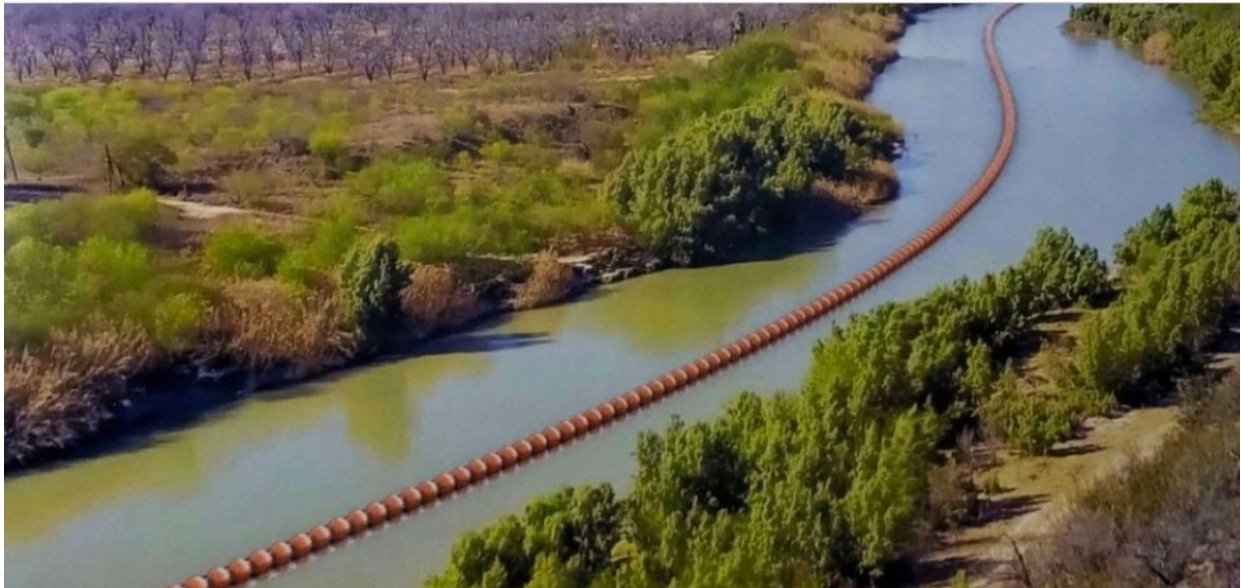
FIGURE 2: REPRESENTATIVE IMAGE DEPICTING THE SCALE OF THE BUOY AND ANCHOR COMPONENTS OF THE PROPOSED SYSTEM. SOURCE: [HTTPS://WWW.CBP.GOV/DOCUMENT/ENVIRONMENTAL-ASSESSMENTS/BORDER-BARRIER-AND-WATERBORNE-BARRIER-SYSTEM-WEBB-AND-ZAPATA](https://www.cbp.gov/document/environmental-assessments/border-barrier-and-waterborne-barrier-system-webb-and-zapata)

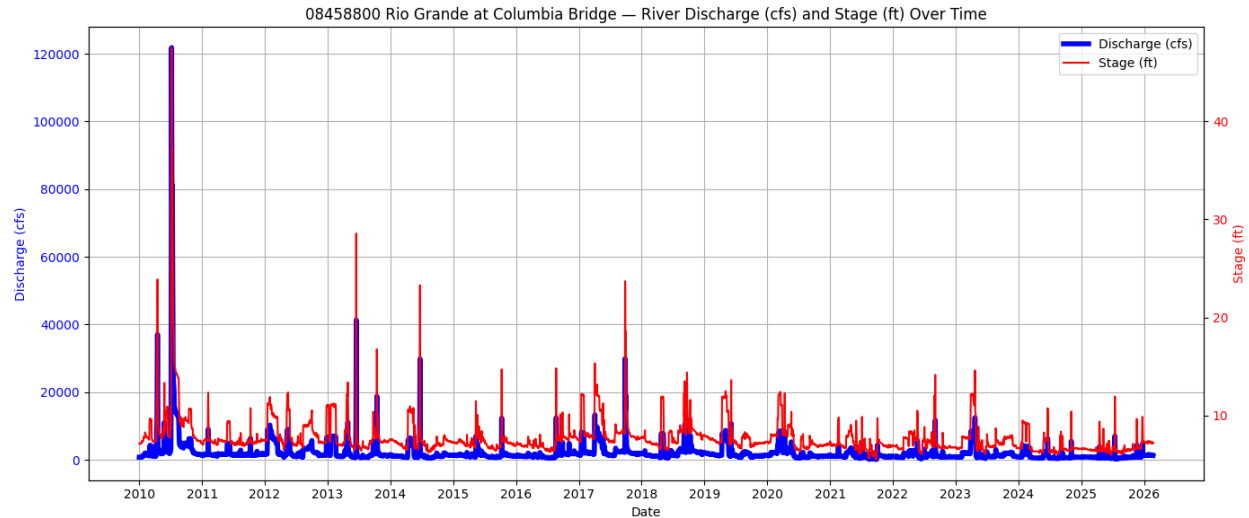
FIGURE 3 – RIO GRANDE FLOW AND STAGE AT THE COLUMBIA BRIDGE FROM 2010 TO 2026.

Hydraulic risk relates to the ways in which the proposed system will alter how water flows through the Rio Grande River. The Rio Grande currently experiences extreme high flows that cause flooding and related damage in Webb and Zapata Counties without the obstructions added by the proposed system. Figure 3 and Figure 4 summarize recent river flows and stages and impact summaries for recent floods, respectively. While the period from 2019 to present has experienced relatively low flow conditions, the period between 2010 and 2018 experience several major flood events. The wall portion of the system will create vast new areas (equal to approximately 35% of the river area itself) along the river that will be hydraulically smooth. In addition, the buoy portion of the system will result in a large new obstruction to flow (up to approximately 8% of the conveyance area of the river channel) in the Rio Grande. Together, the proposed wall and buoy system will result in increased velocities along the smoothed and cleared bank on the U.S. side of the river, elevated flood stages and backwater effects due to lost conveyance area, and flow redirection and increased turbulence due to the dangerous combination of cleared river bank areas adjacent to the continuous flow obstruction caused by the massive chains of buoys. It seems as though the design of the proposed system is intended to increase erosion of the U.S. riverbank and raise water levels throughout the river. During high flows like those experienced between 2010 and 2018, the proposed system will lead to failures in the already stressed flood control system in Webb and Zapata Counties.

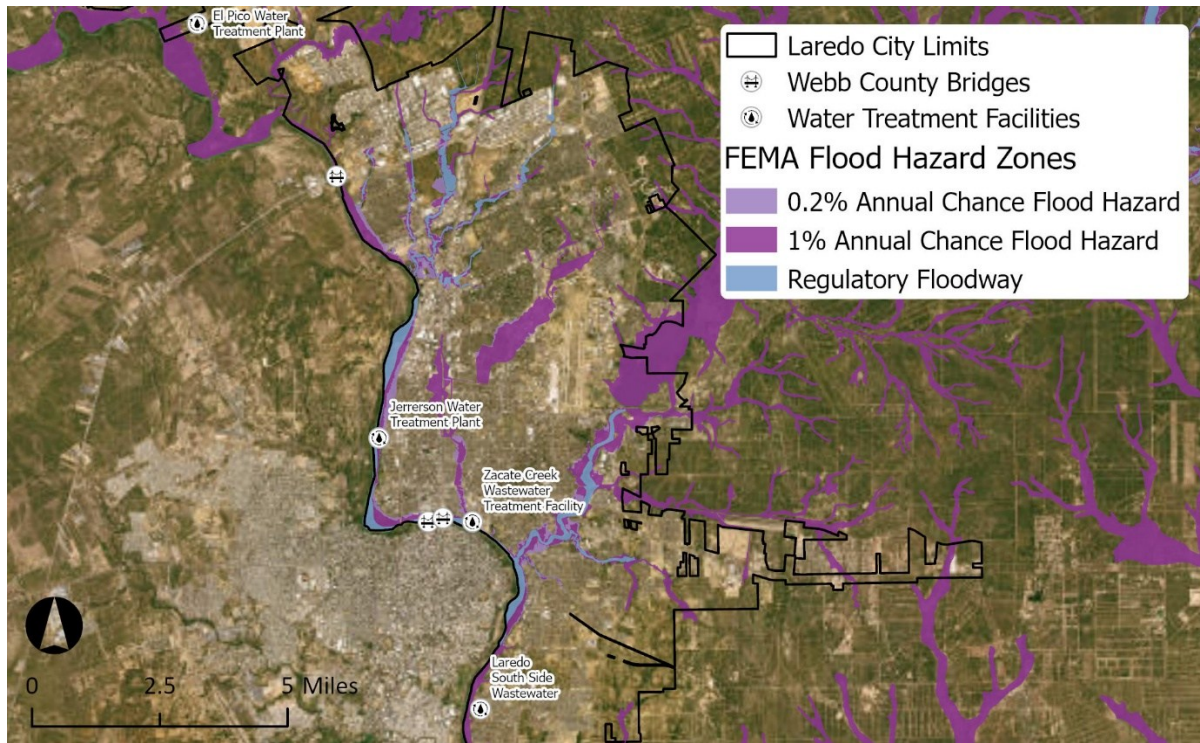
FIGURE 5: MAPPED FLOOD ZONES AND CRITICAL INFRASTRUCTURE ALONG THE RIO GRANDE RIVER IN WEBB COUNTY.

Figure 5 and Figure 6 show the existing flood hazard zones along the Rio Grande for Webb County. In addition, these figures show the locations of bridges, water treatment plants, and wastewater treatment plants. All of this critical infrastructure is in the existing flood hazard zone, meaning that it will be inundated during extreme events. Figure 7 shows how the existing flood control system is already stressed during high flows. The higher flows in the 2010 image in Figure 7 clearly inundate areas well

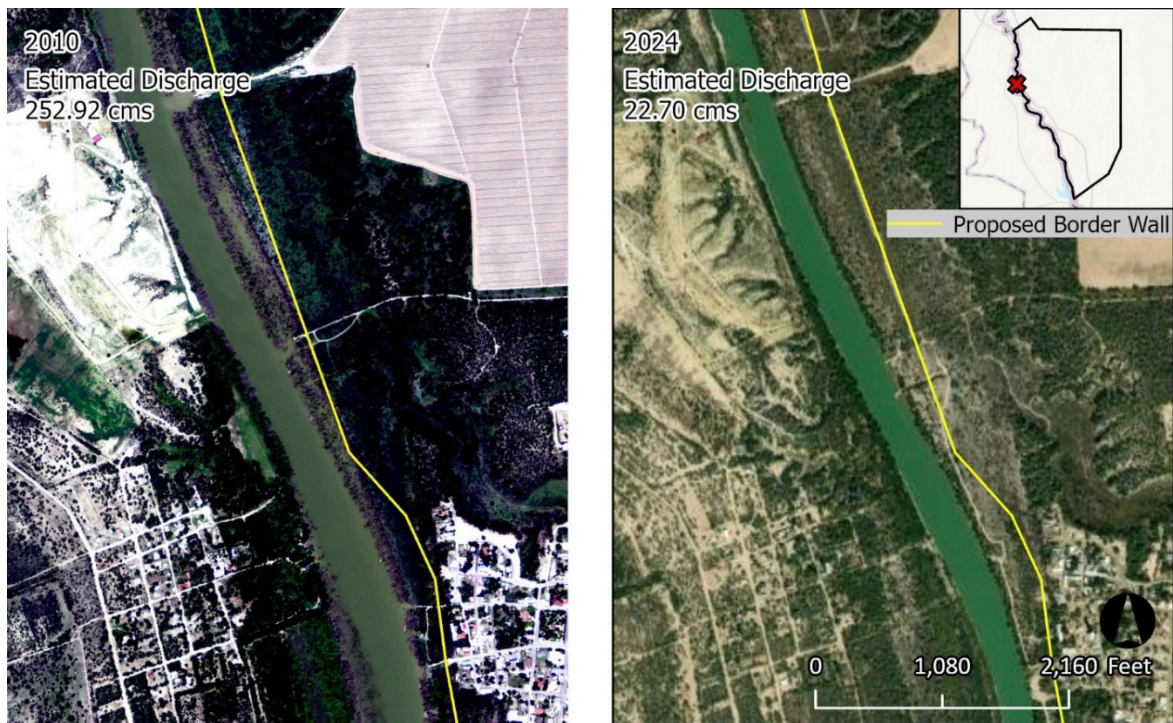
FIGURE 7: REPRESENTATIVE AERIAL IMAGES OF THE RIO GRANDE RIVER IN THE PROPOSED PROJECT AREA SHOWING THE EXTENT OF INUNDATION DURING HIGH FLOWS IN 2010 AND LOWER FLOWS IN 2024.

beyond the river edge, including areas where the new wall is proposed. The proposed wall and buoy system will greatly exacerbate the existing hydraulic risk by raising water levels and redirecting flows into the cleared wall area, resulting in more rapid and extensive erosion of the existing flood control system, and more frequent overtopping of the flood control system. The hydraulic risks of the proposed wall and buoy system are dramatic just considering the presence of the new wall, patrol area, and buoys. However, debris loading (discussed below) will greatly compound this risk and almost certainly result in devastating system failures caused by the hydraulic alterations to the Rio Grande that result from the proposed project.

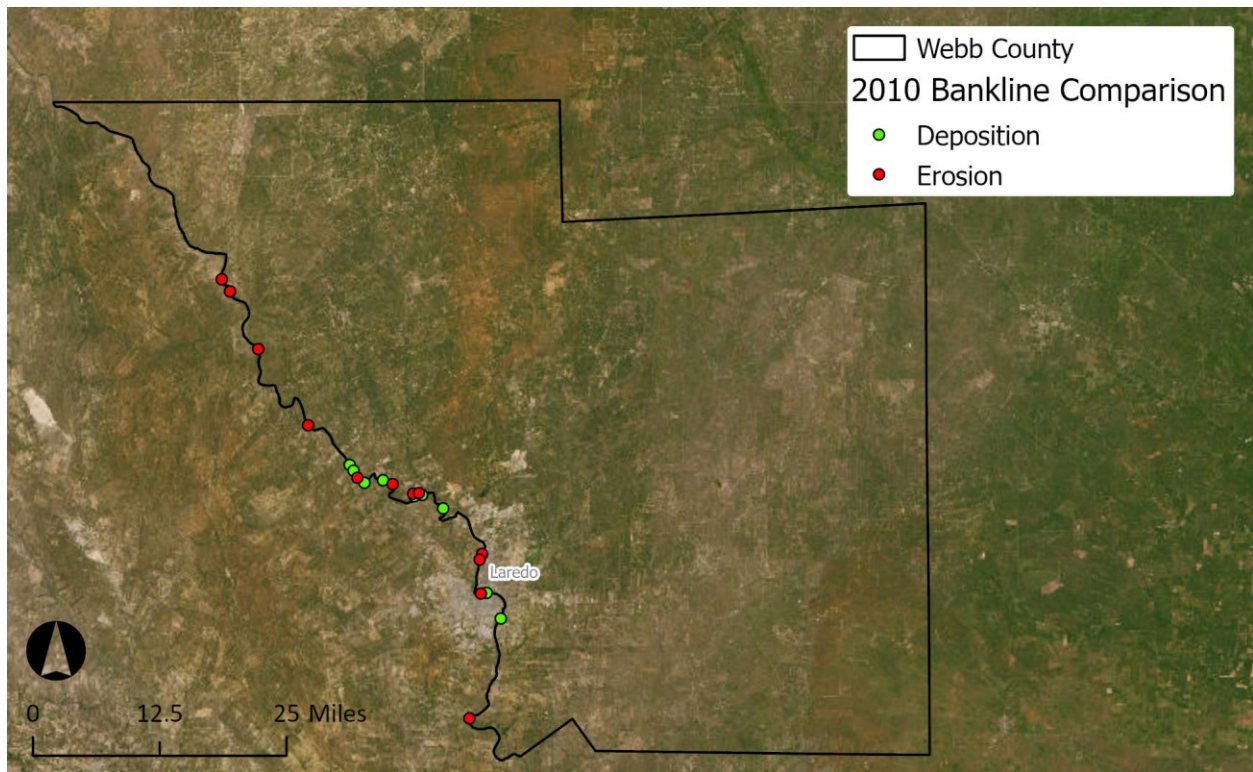
FIGURE 8: HISTORICAL LOCATIONS OF SIGNIFICANT CHANNEL CHANGE ON THE RIO GRANDE RIVER ALONG WEBB COUNTY.

Alterations to the border location from erosion and channel migration are most likely at river bends and areas upstream and downstream of tributary inflows. Figure 8 shows locations of significant historical channel change that has occurred without the proposed project in place. This includes channel migration, bank erosion, and in-channel island formation. Channel change is likely to accelerate in these areas if the proposed system is constructed. Figure 9 and Figure 10 show major island growth and bank erosion, respectively, that has occurred in Laredo. It is extremely important to note that this change has occurred over only fourteen years, which is an extremely small time increment in the evolution of a river like the Rio Grande. The proposed wall and buoy system will greatly increase the geomorphic risk along the river, with accelerated evolution along the U.S. side caused by the denuded channel banks and the proposed border wall. These geomorphic risks will remain even if the proposed border wall is replaced with an earthen berm. Similar to hydraulic risk, the geomorphic risks will be exacerbated during high flows when debris loading focuses the erosion and scour onto bare channel banks and causes rapid and extensive channel migration along the U.S. bank of the river.

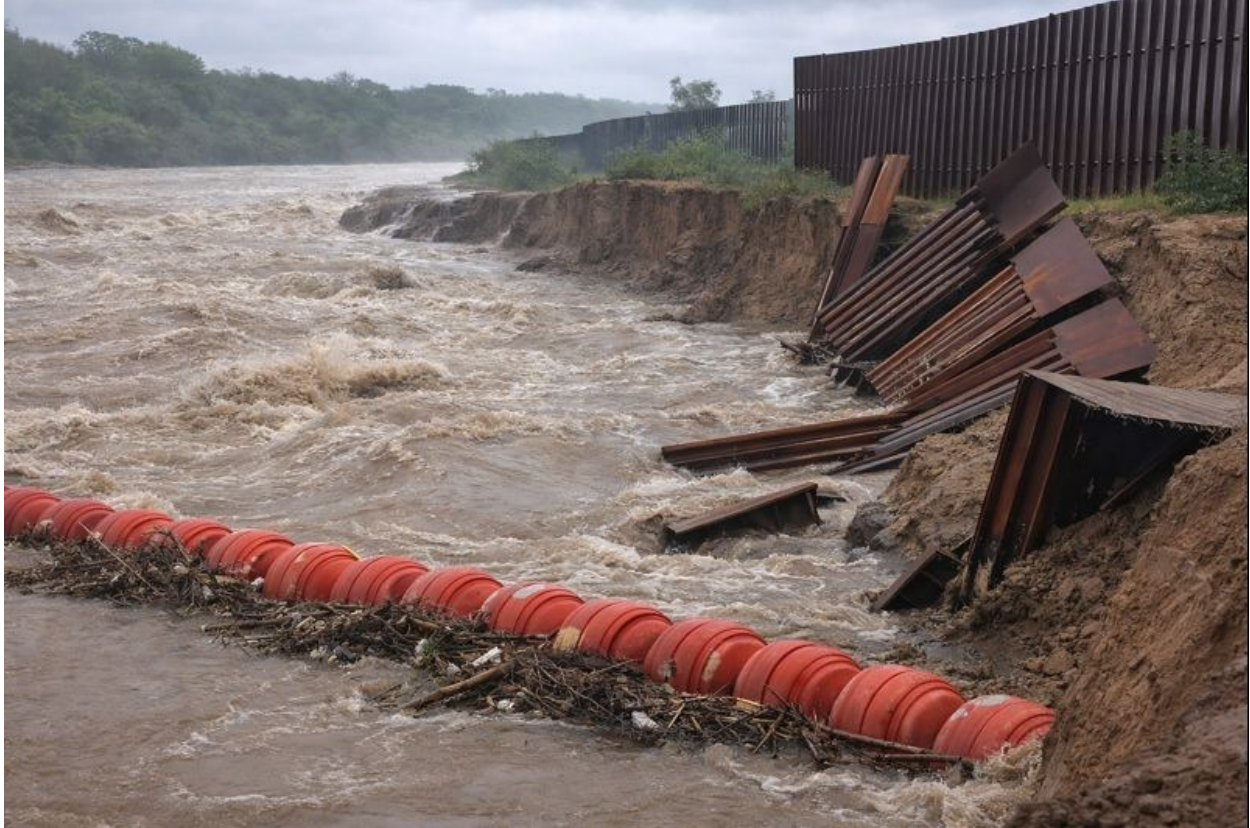
FIGURE 11: ILLUSTRATIVE IMAGE DEMONSTRATING POTENTIAL BUOY BEHAVIOR UNDER HIGH-FLOW CONDITIONS ON THE RIO GRANDE RIVER.

Figure 11 is an illustrative image that shows how debris loading coupled with channel scour could dislodge sections of the proposed buoy chain and transport them to the cleared and erosion-prone channel banks along the proposed wall. Such a failure would accelerate channel migration into the wall and potentially cause portions of the wall to fail. I observed similar erosion along a new border wall near Mission, Texas after relatively low flows and fully expect much more damaging erosion and channel migration when extreme high flows interact with the massive proposed wall and buoy system.

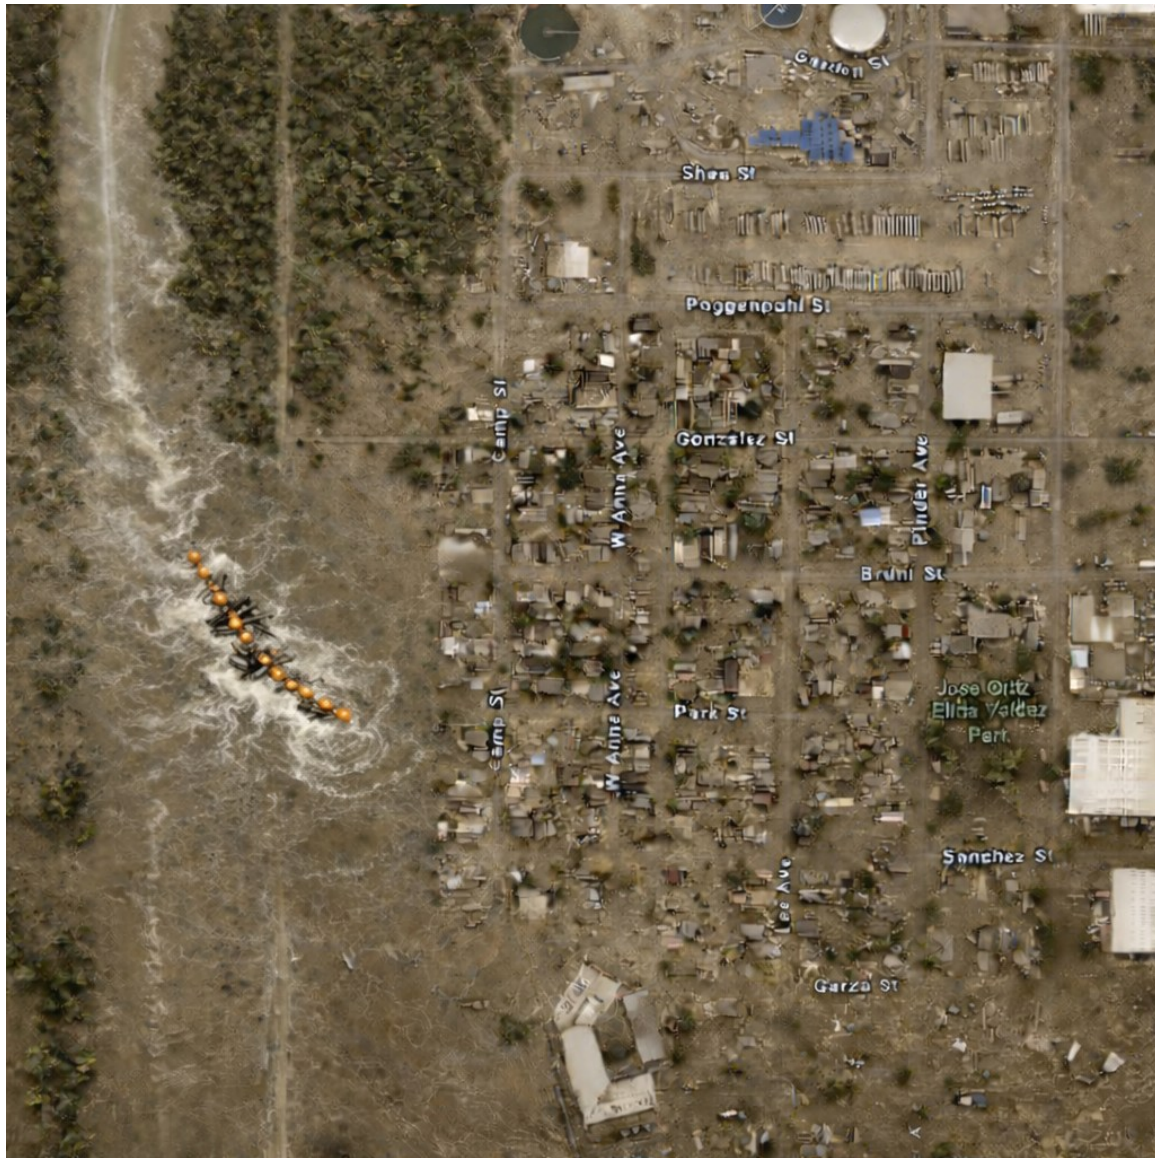
FIGURE 12: ILLUSTRATIVE IMAGE DEMONSTRATING POTENTIAL FLOODING EXACERBATED BY BUOY SYSTEM FAILURE UNDER HIGH-FLOW CONDITIONS IN NEIGHBORHOOD NEAR LAREDO, TEXAS.

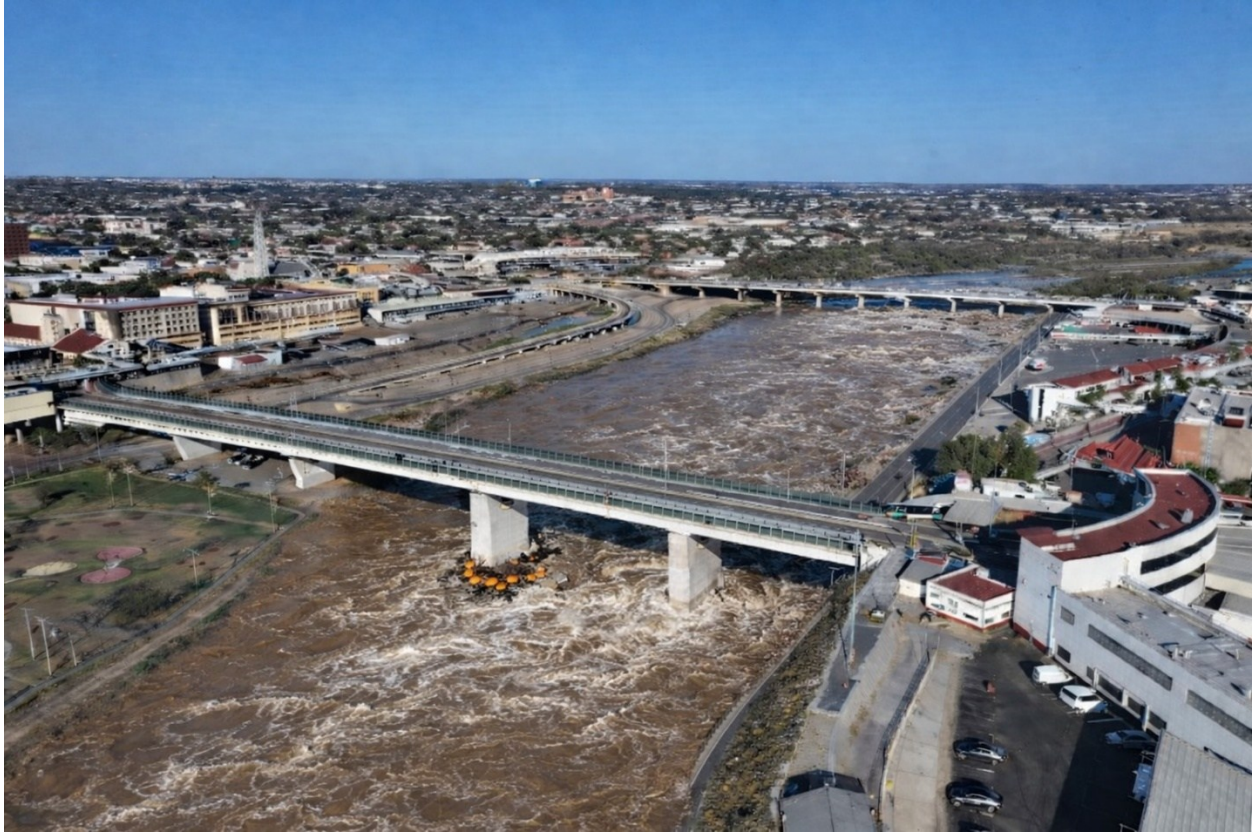
FIGURE 13: ILLUSTRATIVE IMAGE DEMONSTRATING POTENTIAL BUOY BEHAVIOR AT BRIDGES IN LAREDO UNDER HIGH-FLOW CONDITIONS.
